EXECUTIVE SUMMARY

The original building was constructed in 1958 with a major addition constructed in 1967. Most of the systems are original to the building and although functioning, have outlived its intended useful life. The facility's two electrical services are provided by National Grid and are secondary metered. Other incoming utilities include telephone, cable TV, and fiber.

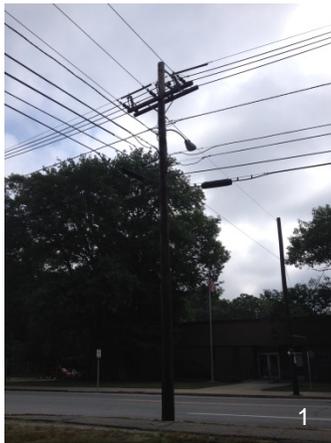
1: Tee-Off Pole at Site

Three phase primary service runs overhead on building side of street where it tees off into the site. Overhead primary continues on site over four pole spans where it transitions to underground at two locations, Pole # 66-2 and Pole# 66-4.

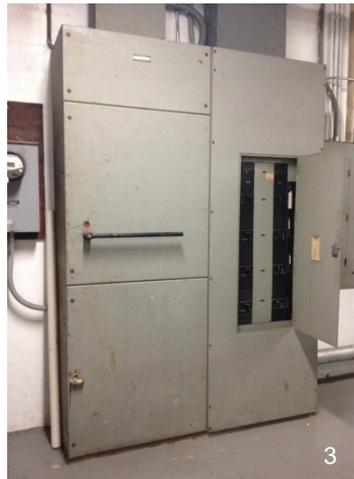
3: 1958 Switchboard

The school is serviced by two electrical services; service #1 feeds the 1958 building, while Service #2 feeds the 1967 building. Service #1 primary originates at Pole# 66 -2 where it runs underground in one 4" conduit into a transformer vault. The vault has exterior access to national grid only. Secondary service originates in the vault and runs overhead to an unlabeled switchboard manufactured by the Kelek Co. The switchboard is rated at 120/208 V, 3Ø, 4W and is located in the boiler room.

The switchboard has a C/T and main disconnect section and a breaker distribution section. The electric meter is located adjacent to switchboard.

In general, most switchgear is original to building ranging in age from 48 years to 57 years old. Condition ranges from fair to poor. The rating of both electric services reflects original electric heat which has been converted to natural gas. Thus, the switchgear due to its age and condition should be replaced under a renovation program with a single electrical service.

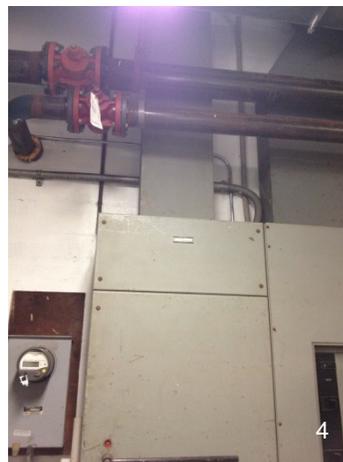
4: Gas Pipe of Switchboard

Gas service pipes run directly above the switchboard.

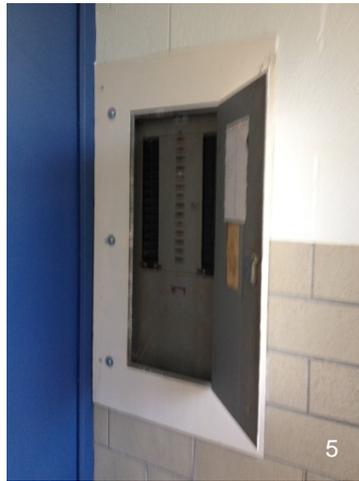
5: Corridor Flush Panel

Most panelboards are original KeLek Co., while others are newer Siemens and GE. Panelboards are of the break type located throughout the facility. Most panels are generally full and in poor condition.

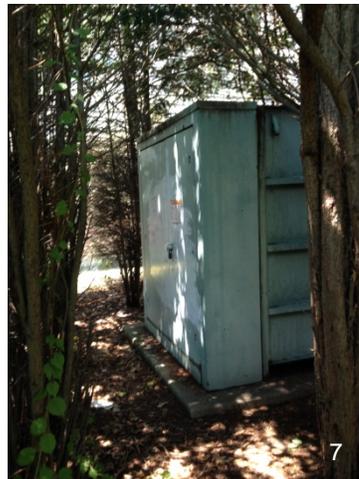
7: Pad-Mounted Transformer

Service # 2 primarily originates on Pole # 66-4, where it runs underground in one 4" conduit to an exterior pad-mounted transformer: concealed by trees and shrubs. Secondary service runs underground between the transformer and a 4,000 Ampere, 277/480V, 3Ø, 4W switchboard located in the electrical room on the second floor.

The existing electrical services should be upgraded with a single 277/480 volt system to provide the required capacity for the building load based on 10 watts per square foot power consumption. A new pad-mounted transformer with new underground primary and secondary services should be provided. The vault-mounted and pad-mounted transformers would be removed when no longer needed.

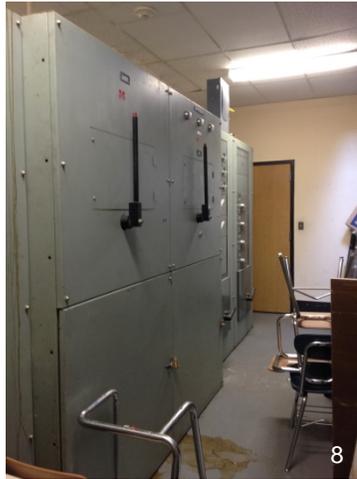
8: 1967 Switchboard

The switchboard, manufactured by Westinghouse, is master-metered with a 4,000 Amp, main disconnect C/T section. In addition, the switchboard is split into three sub main disconnects C/T sections each separately metered as follows: one 3,000 amp for electric heat, one 800 amp for general light and power, and one 600 amp for electric hot water.

The switchgear manufactured by Westinghouse is original and is in fair condition. A fusible switch has been mounted to the top of the board due to lack of mounting space. The switch is not readily accessible. The electric room and switchgear layout do not meet current codes which require doors to swing out and provided with panic hardware.

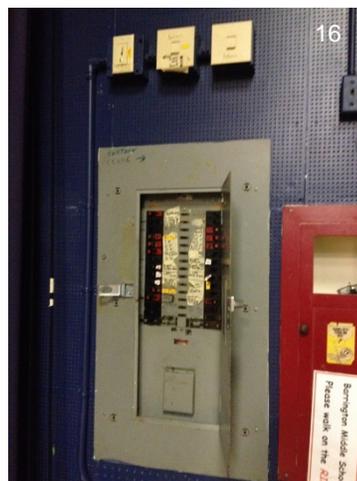
16: Wall Dimmers on Stage

Auditorium house lighting consists of recessed down lights with halogen lamps controlled with wall dimmers located on stage. Performance lighting consists of one row of border lights on stage and three dual par lamp holders on front of house. Performance lights are breaker controlled from panel board located at stage. Stage work lights consist of 2X4 recessed troffers.

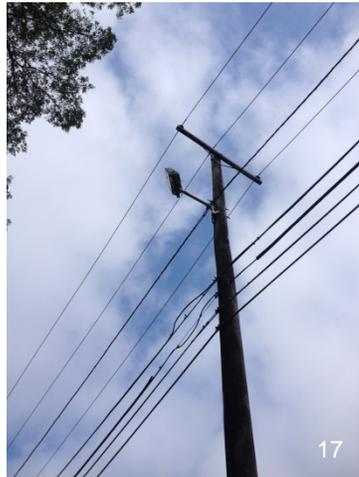
17: Flood on Utility Pole

The exterior lighting consists of HID floods on utility wooden poles at rear parking areas and grassy area.

Exterior lighting is not of the cut-off type. Various fixtures were on during daylight.

In general, exterior lighting is not energy efficient and provides inadequate lighting. The exterior lighting should be replaced with LED cut-off luminaires and controlled with photocell “ON”, timed off.

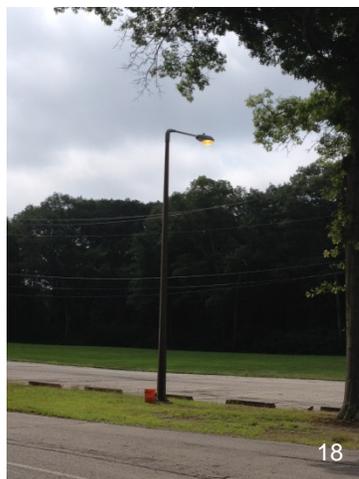
18: Cobra Head on Concrete Pole

The front parking area is lit with high pressure sodium cobra heads on concrete poles. Canopy has non-functional fluorescent strips abandoned in place.

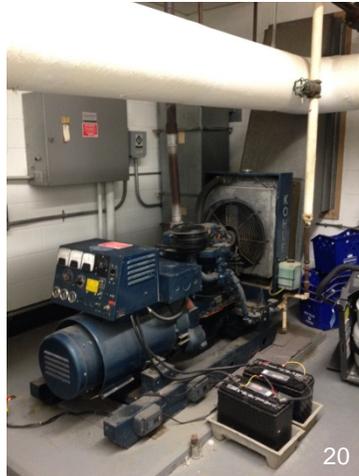
The 1967 building has a 25kw, 120/208V, 3Ø, 4W natural gas generator. The generator is a Kohler #30R629104A and is in poor condition. One 100 Amp Zenith automatic transfer switch is located in same room. The generator and transfer switch share the same room with the water heaters. An extension cord runs on the floor used to charge the batteries.

The emergency system is original and inadequately sized, and is not code compliant.

The emergency system should be replaced with a code compliant system.

Provide a new exterior emergency generator and automatic transfer switches to provide emergency backup power for life safety and essential standby loads (i.e.; freezers, communications and security equipment, boilers, pumps, etc.) Dedicated 2-hour fire rated emergency rooms shall be provided within the building. Life safety system will feed all code required egress lighting and exit signs.

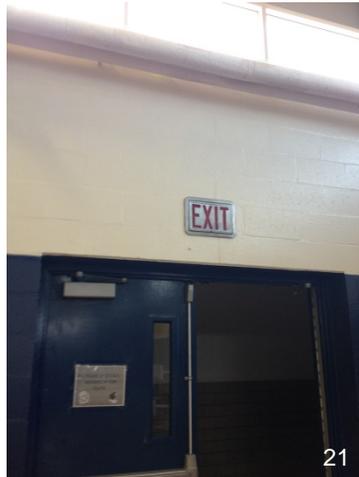
21: Gym Exit not lit

There is no emergency lighting on exterior doors. Exit signs have compact fluorescent lamps; some exit signs are not lit, including the Gym and Auditorium.

Exit signs are not energy efficient and coverage is inadequate in many spaces.

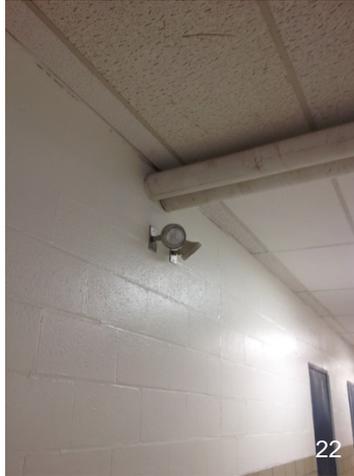
*22: Remote Emergency
Lights*

Battery operated remote heads are used for egress lighting in the 1958 building.

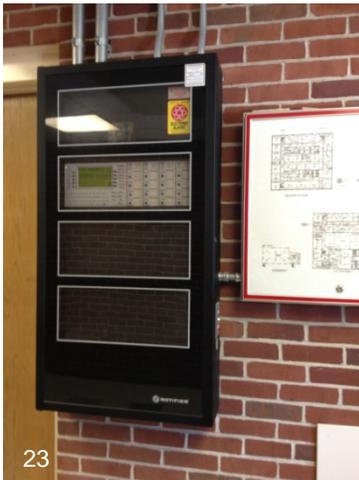
23: Fire Alarm Panel

The fire alarm system for the facility consists of a newer replacement Notifier 3030 panel located in the Main Lobby. A graphic LED annunciator is located adjacent to FACP. The form of alarm transmission is via a Sigcom radio box.

The fire alarm system, although recently upgraded, does not have voice evacuation, which is currently required by code.

The fire alarm and detection system could be re-used and expanded. It is recommended that the horns be replaced with voice evacuation speakers. The system is of the addressable type where each device will be identified at the control panel and remote annunciator by device type and location to facilitate search for origin of alarms. Smoke detectors will be provided in open areas, corridors, and other egress ways. The sprinkler system will be supervised for water flow and tampering with valves. Voice evacuation speaker/strobes would be provided in egress ways, classrooms, assembly spaces, open areas and other large spaces.

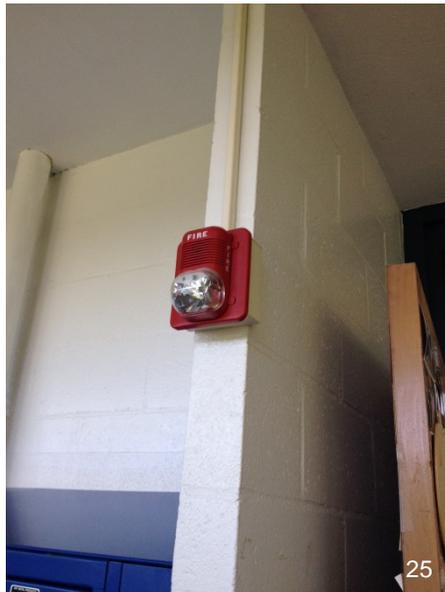
25: Horn/Strobe Unit

The audible devices consist of horns. The visual devices are ADA compliant. Coverage appears fair. Smoke detectors exist in corridors, classrooms, stairwells, and most spaces. Heats exist in kitchen, boiler room, and home economics. Smokes in Gym have wire guards. The Auditorium has (2) smokes. The kitchen hood does not have a fire suppression system.

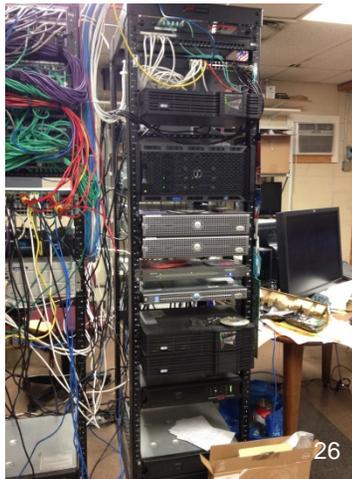
26: IT Rack

The data cabling infrastructure is generally CAT5. Typical IDF communications racks are located throughout the school interconnected with CAT5 cabling. Racks are not located within conditioned dedicated rooms. Wireless access nodes exist throughout school. Typical classroom has one data outlet.

Tel/Data wiring should be replaced with CAT6 plenum rated cable throughout. New outlet locations should be reviewed to accommodate the facilities new technology equipment plan. A new head end room with 50 micron laser optimized multimode and single mode cable to remote dedicated IDF rooms should be provided for gigabit connectivity to the desktop. The new dedicated data closets will ensure that present and future data needs are accommodated.

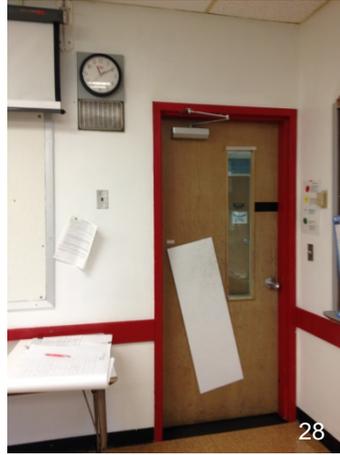
28: Clock/Speaker Call-In Switch

Each classroom has a wall-mounted call-in switch and wall speaker to communicate with the Main Office. The call-in switch is located at 5' above floor which exceed ADA.

The existing classroom intercom system should be replaced with a state of the art intercom system with web based software. Each classroom

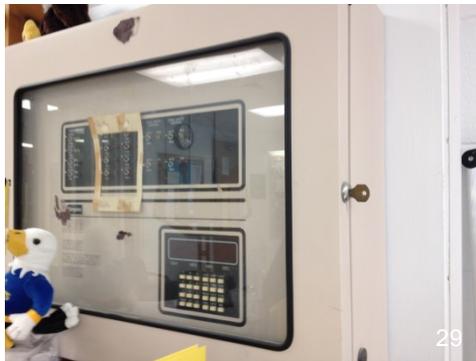
29: Clock Controller

The Simplex 2400 master clock system controller is located in the Main Office, but is not functional. A battery operated clock is located in each classroom.

should be wired back as an individual home run for private conversations. New speakers should be located throughout the facility to ensure adequate coverage and capable of flexible selective zone paging. The existing master clock system should be replaced with a new GPS based wireless master clock system with repeaters in the IDF closets and 120V wireless secondary clocks located in each classroom, office, and large space as needed.
