EXISTING SITE AMENITIES

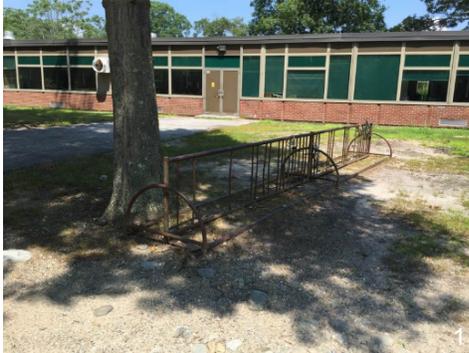
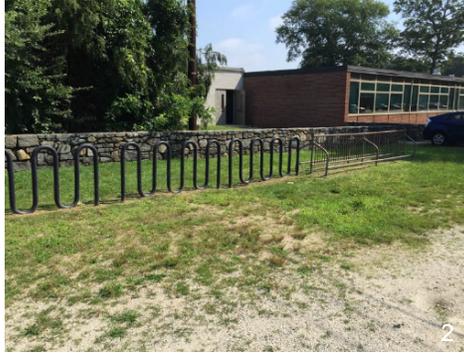
1 & 2: Bike rack styles along southern side of school

Bike racks are of varying styles, age and installation methods. They allow for high capacity. One bike rack is powder coated blue, newer in age with smaller capacity, see photo 4 below.

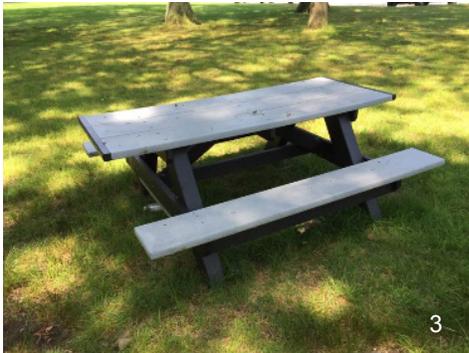
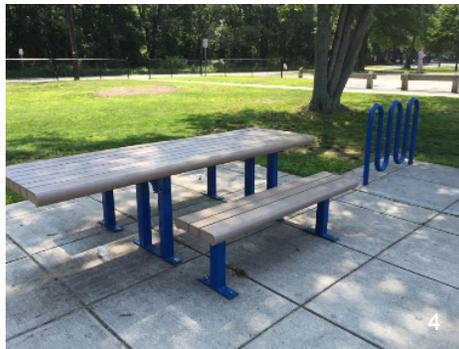
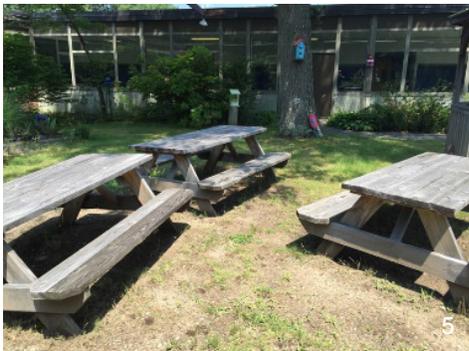
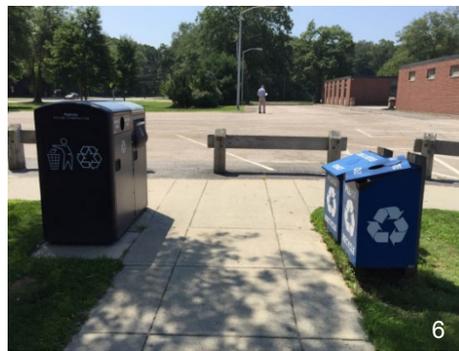
*3: Recycled material picnic tables at southeast open space
4: Accessible Picnic table near basketball courts
5: Wood picnic tables in courtyard
6: Litter and recycle containers*

Picnic tables vary in age and style around the campus. Only one picnic table near the basketball courts is handicap accessible. Only litter receptacles observed on site are the solar compactor units and recycle bins. Both sets are in good condition.

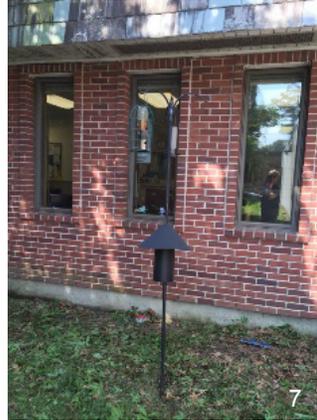
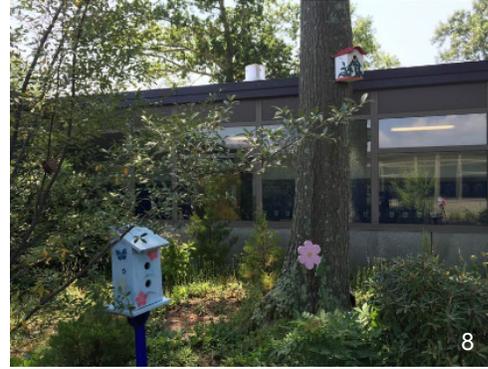
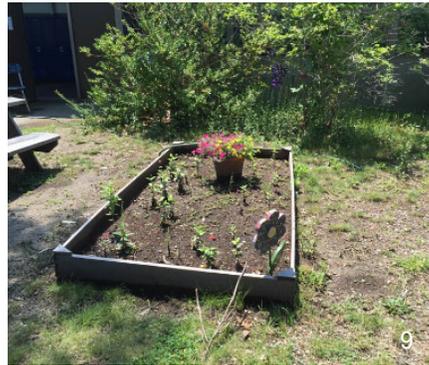
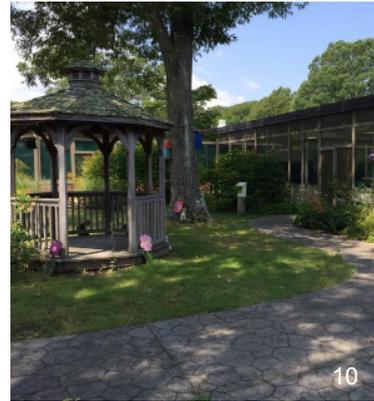
Birdfeeders are present both on the south side of the building hidden in the vegetation and there are a number of feeders in the courtyard. There are raised beds in the courtyard as well as a small fish pond. The courtyard appears to be well used by the number of picnic tables, decorated feeders and gazebo.

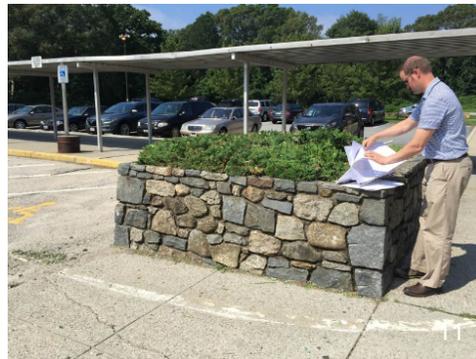
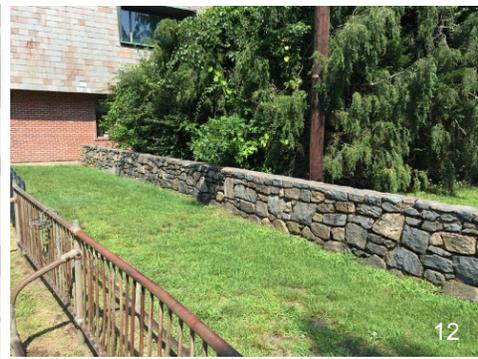
Free standing masonry walls on site include one near the main bus drop off area and one between the original building and the addition. Masonry is in good condition and re-use of stone may be possible.

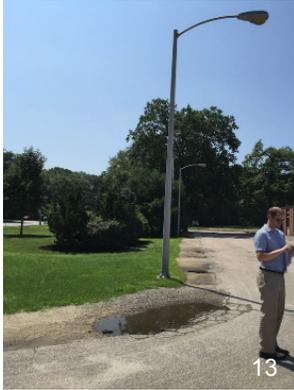
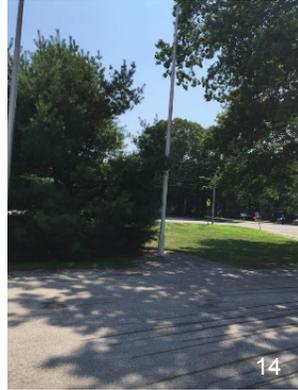
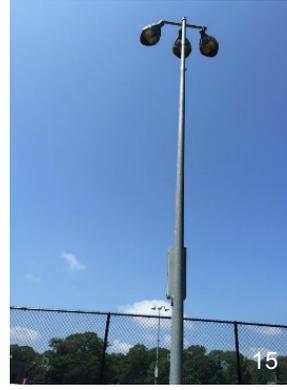
There are standard DOT style overhead lights in some areas around the drives and parking lots. Some parking and walkway areas do not have lights. There is one light near the flagpole. Up-lights for the flagpole were not observed. There is athletic lighting around the ball fields.

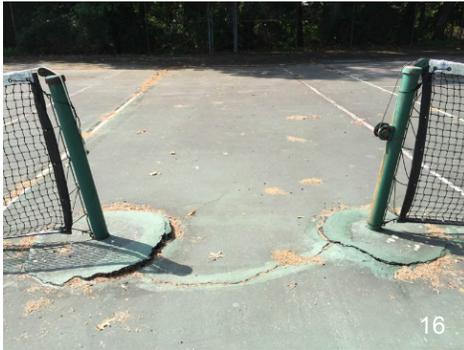
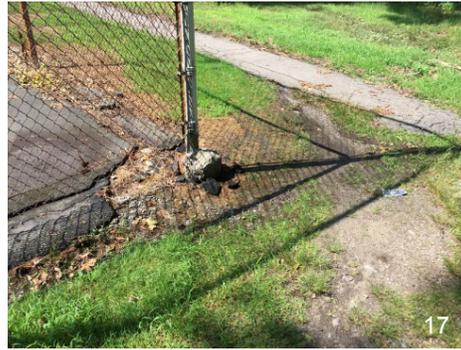
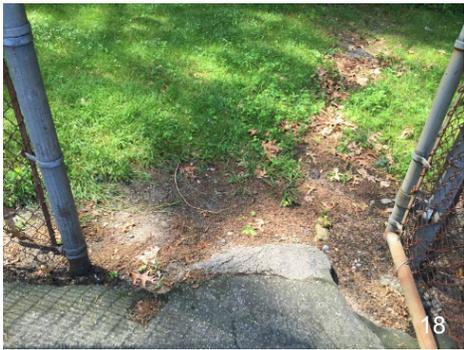
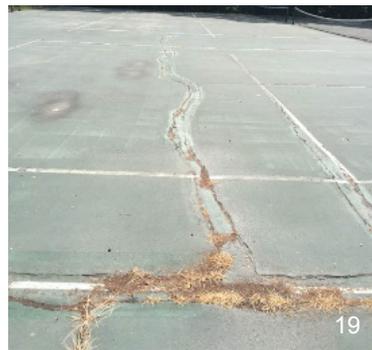
Tennis court area includes four courts in poor condition. Drainage, groundwater and age have caused cracking, erosion and varying degrees of settling.

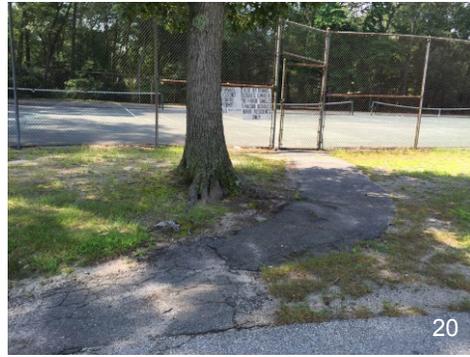
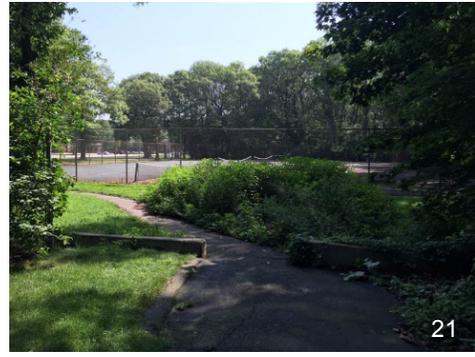
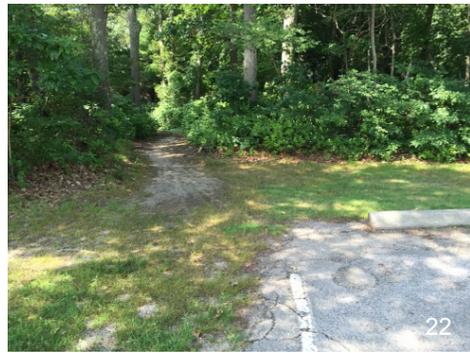
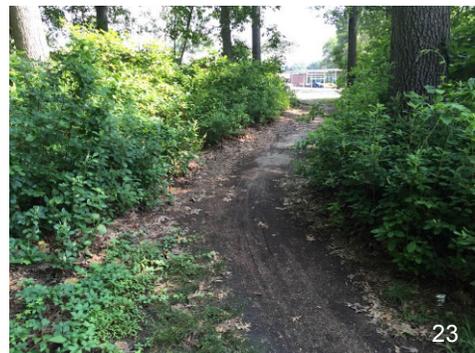
There are two paths leading to the tennis courts from adjacent drives and parking areas. The paths are in poor condition and neither paths are ADA accessible.

There are also two paths from the tennis courts to adjacent neighborhood streets. One path is paved and in poor condition where erosion has occurred. The other path is a worn path through the woods with part of the path at a low point where water is draining through in storm events.

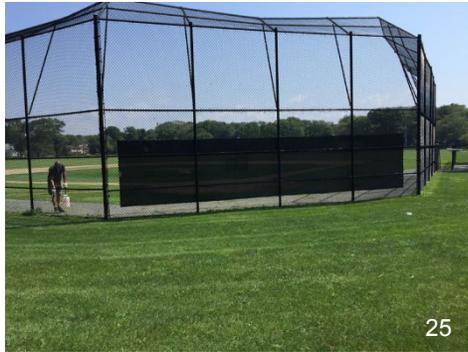
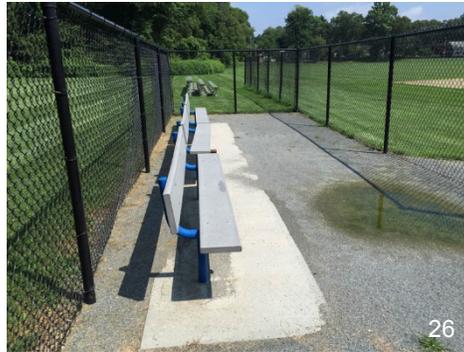
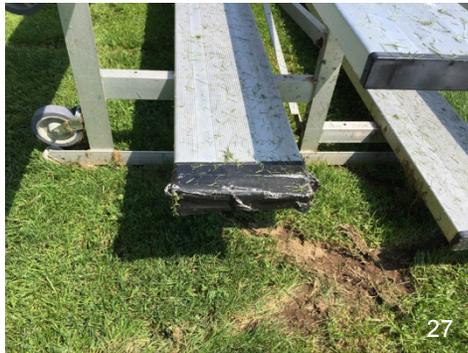
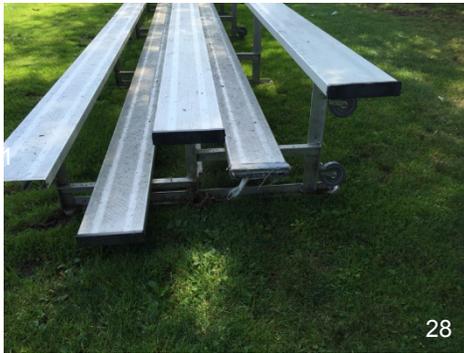
The baseball field fencing was in good condition. Team benches were in fair condition with one seat detached from the support. A few caps on posts were missing and bleacher end caps were damaged, duct-taped or missing.

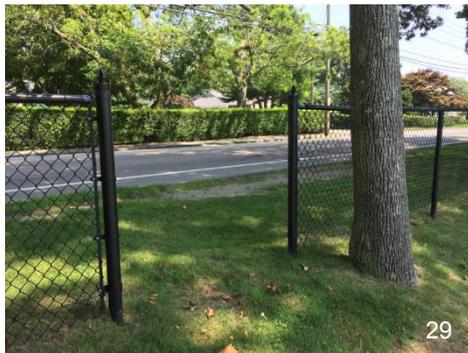
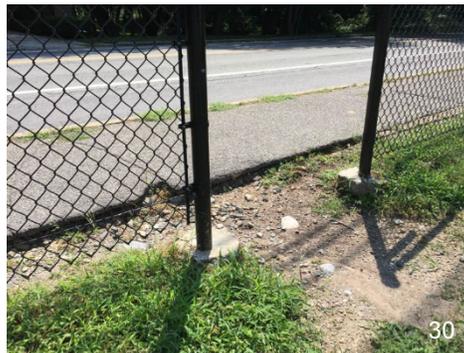
Perimeter fencing – There were four openings along Lincoln Avenue and Middle Highway. Fence was in good condition. Some erosion was observed along Middle Highway due to the higher use and sidewalk. There is no public sidewalk along Lincoln Avenue.

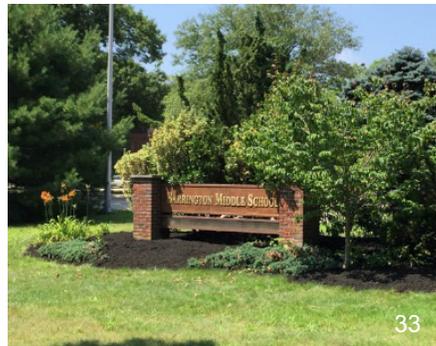
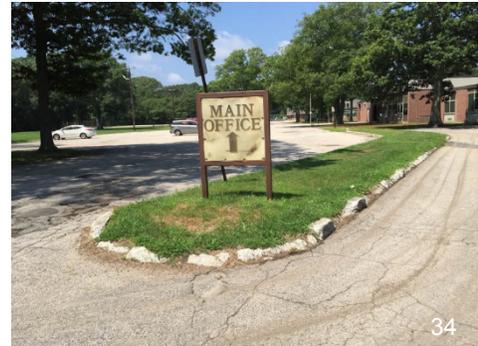
There are two signs along Middle Highway. One is a brick and wood sign in good condition with landscaping around the sign. New mulch was being installed the day of the site visit. The other sign is a directional sign indicating how to get to the main office which is not located at the front of the school. The sign is in poor condition.

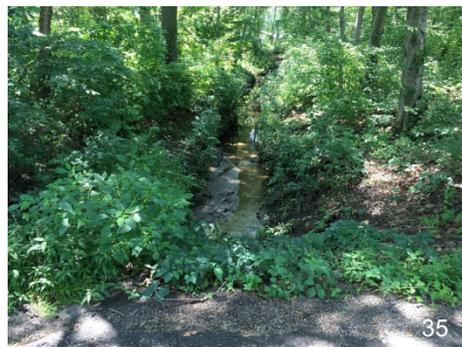
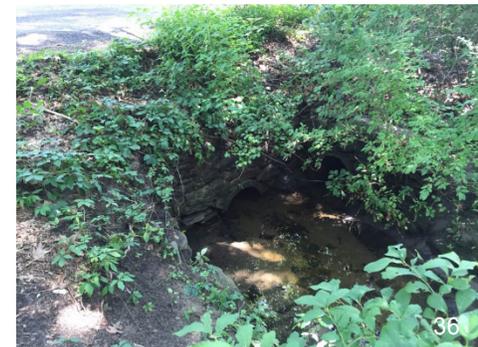
Adjacent to the exit drive near Middle Highway there is a drop off to a stream channel. The drop off is approximately four feet and there is no safety barrier or guardrail.

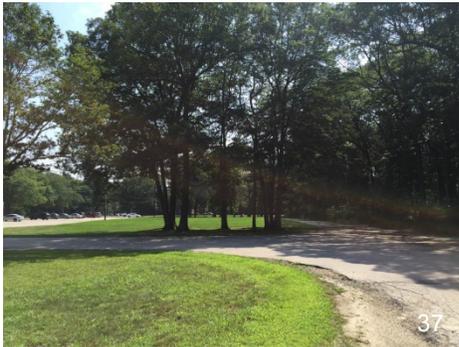
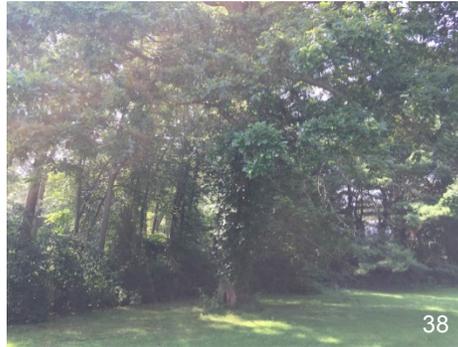
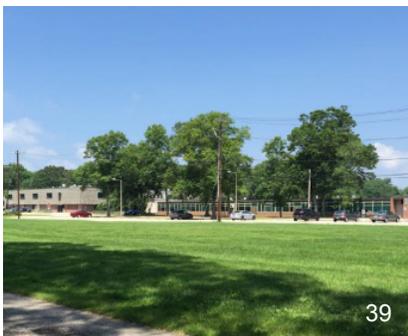
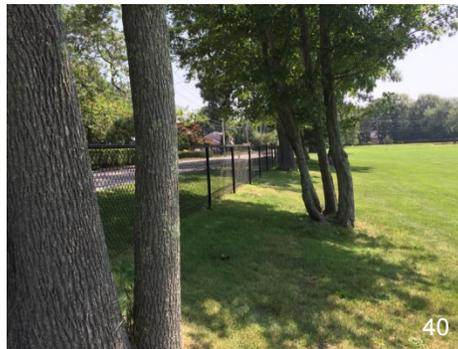
There are several single specimen trees, mostly Oak species within lawn areas around the school. It is recommended that a Certified Arborist review each of these trees and prepare a report indicating their overall health. There is an opportunity to remove select trees that are or may become hazards as well as preserve select trees and incorporate them into renovation or new construction.

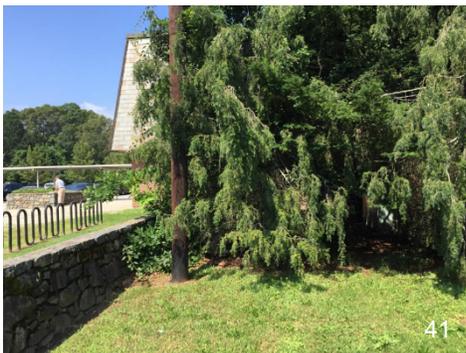
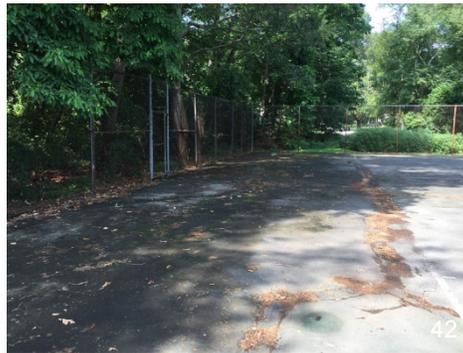
There are overgrown trees causing site line or safety concerns near the school. There is also vegetation growing too close to the tennis courts with no maintenance boundary around the exterior of the fence and causing heavy shade and root penetration.

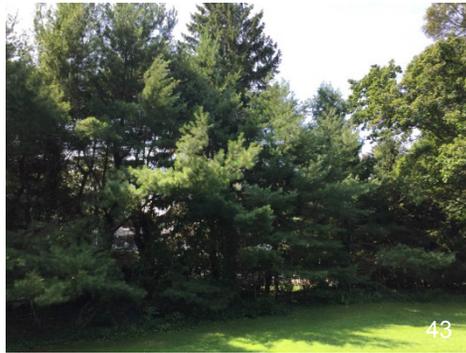
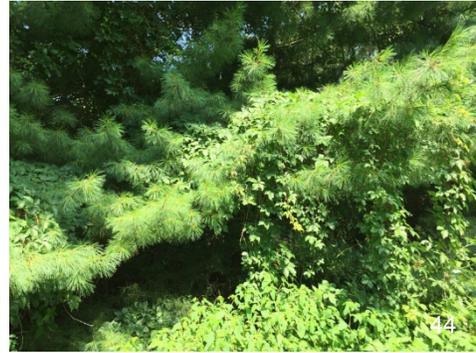
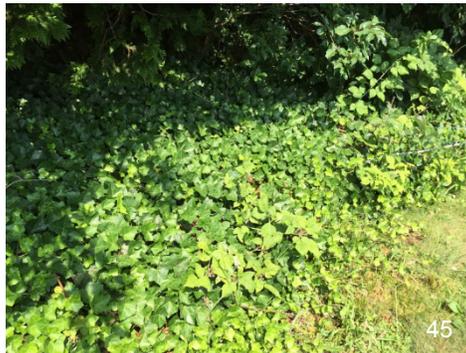
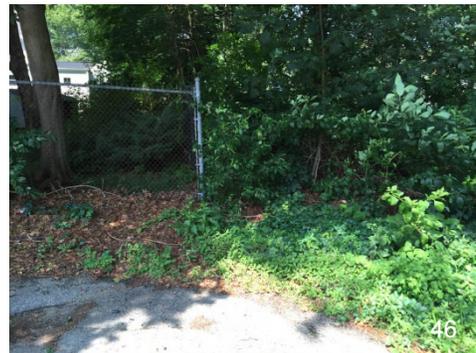
The surrounding south and west tree lines are thick with a mix of native and non-native evergreen and deciduous trees. There is an aging evergreen buffer near a neighboring residential area to the southwest of the site. This buffer should be increased to provide better screening year round. There are numerous invasive or overgrown vines climbing fences and trees and creeping into the lawn area including:

- *Hedera helix* – English Ivy
- *Toxicodendron radicans*– Poison Ivy
- *Rubus* spp. - Raspberry
- *Parthenocissus quinquefolia* - Virginia Creeper
- *Rosa multiflora* - Multiflora Rose
- *Celastrus orbiculatus* – Asian Bittersweet

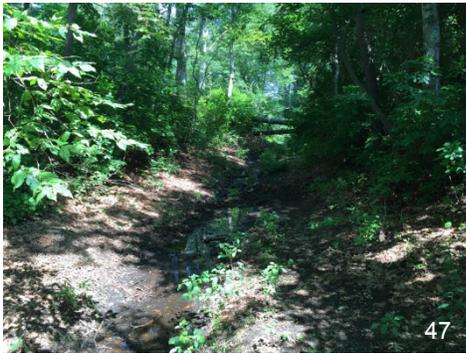
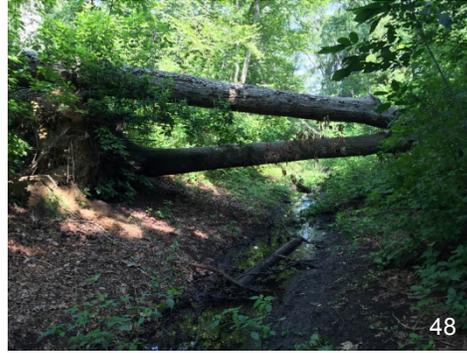
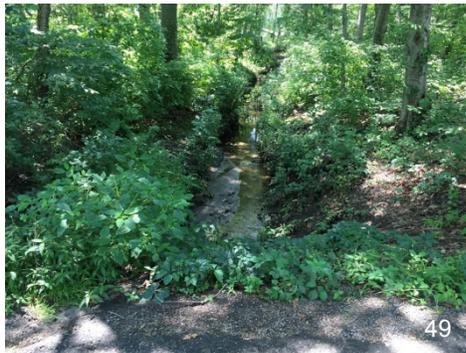
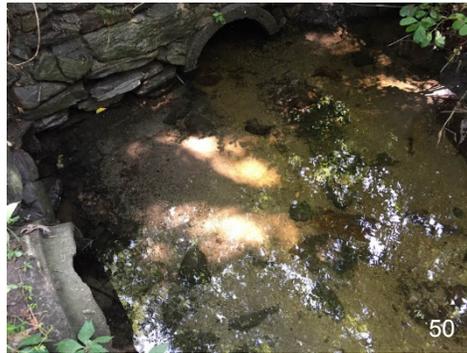
There is a stream channel that runs from the northwest to the southeast. It runs underground through the majority of the developed school property and daylights at the northwest corner and southeast corner. There is an opportunity to expose this stream through the developed school site and have it incorporated with a new low impact storm water management system. This has the potential for a more developed outdoor environmental education program.
