EXECUTIVE SUMMARY

The original building was constructed in 1958 with a major addition constructed in 1967. Most of the systems are original to the building and although functioning, have outlived its intended useful life. The facility's two electrical services are provided by National Grid and are secondary metered. Other incoming utilities include telephone, cable TV, and fiber.

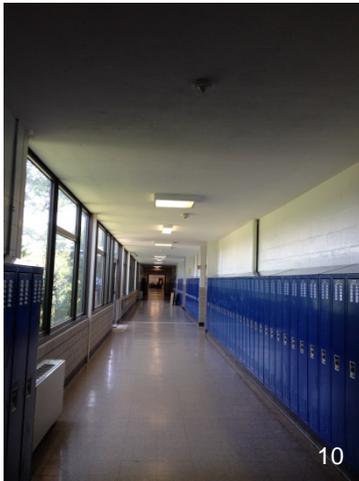
10: Surface Corridor Fixtures

The lighting has been retrofitted with T8 lamps and electronic ballasts. Corridor lighting consists of surface and recessed 2X2 troffers with acrylic lens with 2 UT8 Corridor daylight monitor areas have wall cylinders with Halogen Lamps. Corridor lighting is controlled with local switches except for efficiency lights.

Under a renovation program, the lights should be replaced with LED sources.

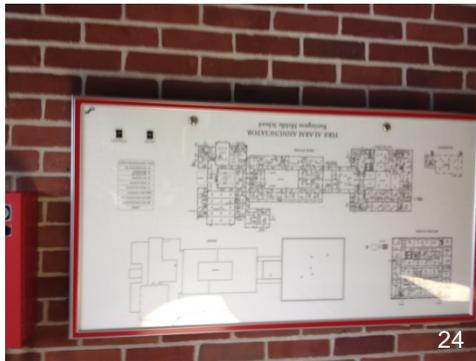
24: Annunciator

The fire alarm system for the facility consists of a newer replacement Notifier 3030 panel located in the Main Lobby. A graphic LED annunciator is located adjacent to FACP. The form of alarm transmission is via a Sigcom radio box.

The fire alarm and detection system could be re-used and expanded. It is recommended that the horns be replaced with voice evacuation speakers. The system is of the addressable type where each device will be identified at the control panel and remote annunciator by device type and location to facilitate search for origin of alarms. Smoke detectors will be provided in open areas, corridors, and other egress ways. The sprinkler system will be supervised for water flow and tampering with valves. Voice evacuation speaker/strobes would be provided in egress ways, classrooms, assembly spaces, open areas and other large spaces.

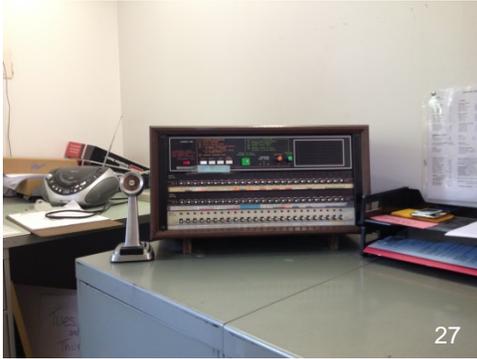
27: Intercom Console

The paging system console, located in the main office, is a Bogen model SBA-225 with microphone. Paging is through a desktop digital telephone handset. Paging speakers exist throughout the school.

Each classroom has a wall-mounted call-in switch and wall speaker to communicate with the Main Office. The call-in switch is located at 5' above floor which exceed ADA.

The existing classroom intercom system should be replaced with a state of the art intercom system with web based software. Each classroom

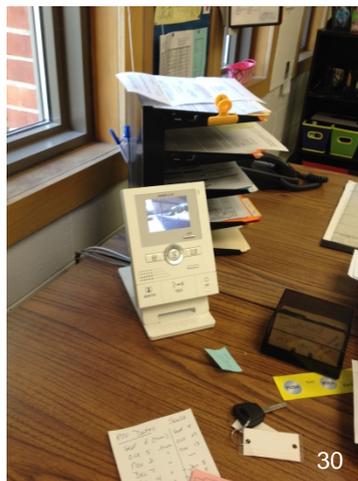
30: Door Intercom

There is an Aiphone video/intercom station at the Main Entrance door with a door release console Aiphone JK-IMD at the Main Office.

A new addressable security system using motion detectors on all perimeter rooms on the first level and all corridors on each level is recommended. Each exterior door will have door contacts for monitoring door position and security keypads provided at each major entry point to the facility. An integrated CCTV and access control system should be provided with building mounted IP cameras covering the perimeter of the building and each major entrance. Card readers should be provided at major entrances to the building.
