EXISTING SITE AMENITIES

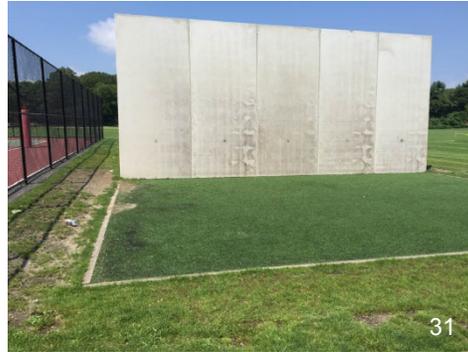
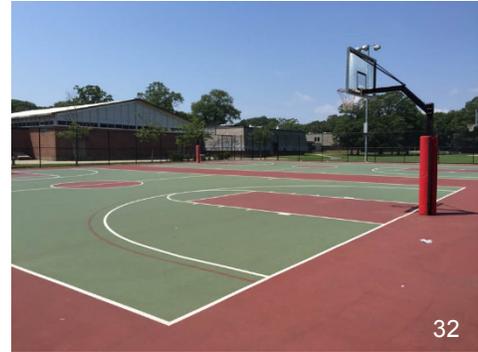
There is a ball wall accessed on both sides with a synthetic turf play area. The two basketball courts were in good condition.
